# LR55 Field Installation Rotherham Bus Station Trial FINAL REPORT

1993 - 1995

by Karen Putensen (1995)

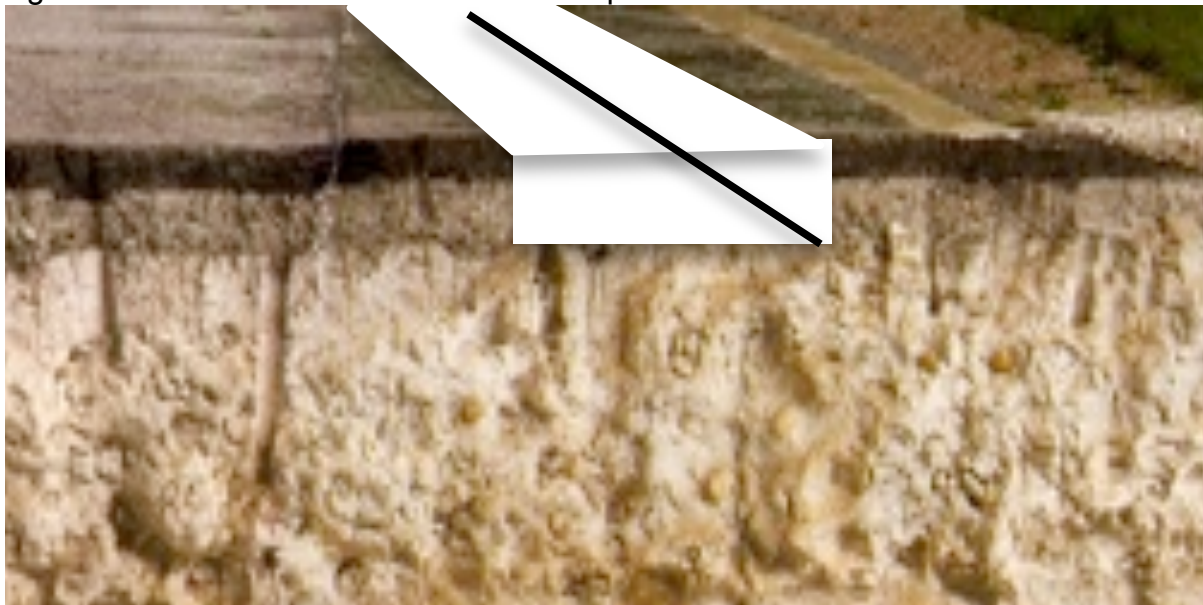
Fig. 2 Rotherham bus station schematic: apron excavated for LR55 beams

LR55 recesses 200mm deep and 400mm wide

On Sunday 14th March 1993 contractors employed by South Yorkshire PTE cut the pavement at the location of the trial using diamond tipped disc cutters. Two parallel 5m saw cuts 400mm apart were made. The pavement between the saw cuts was then excavated to a depth of 200mm and the bottom of the trench was levelled. A bedding layer some 20mm thick of 1:4 dry mix was spread over the bottom of the trench. Onto this bed the concrete foundation beams were laid, lined and levelled. The beams were mechanically connected with steel dowels. When the troughs were laid, the gap between the edge of the troughs and the pavement was filled with a bitumen based mastic sealer. The troughs were then temporarily plated over.

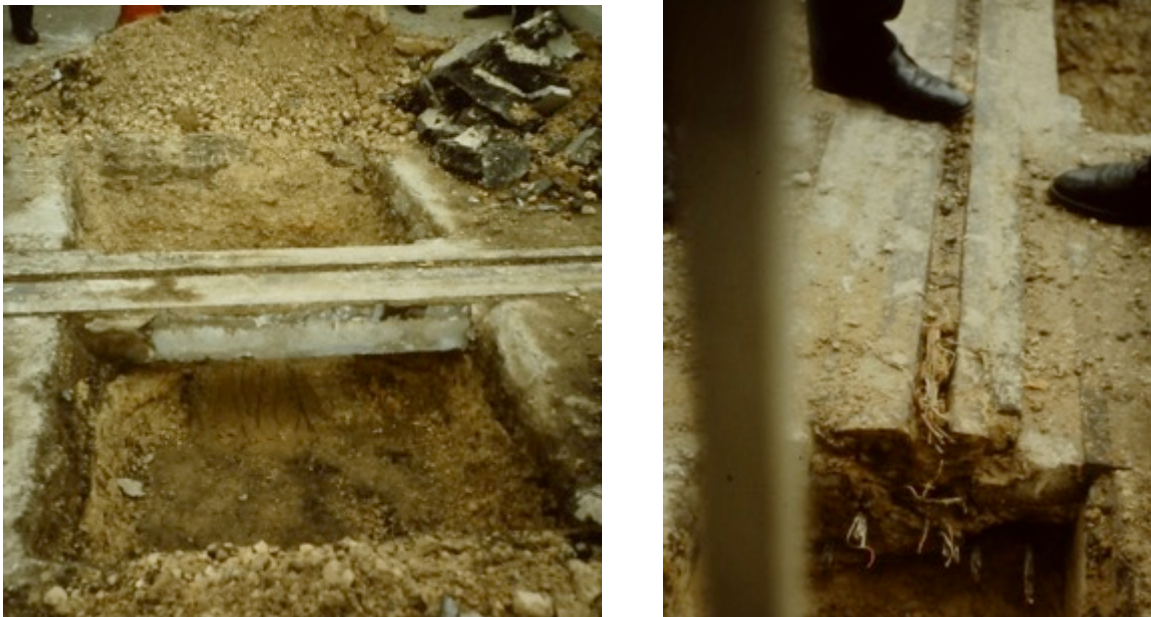
Fig. 15 After 1 million buses - LR55 excavated to examine condition

As interesting for the contractors who attended was the state of the pavement and under pavement conditions, revealed by the excavation. The photograph below shows that the pavement to be thinner than the LR55 foundation beam, and that the ground underneath was a heterogeneous mixture of materials with a low CBR value.

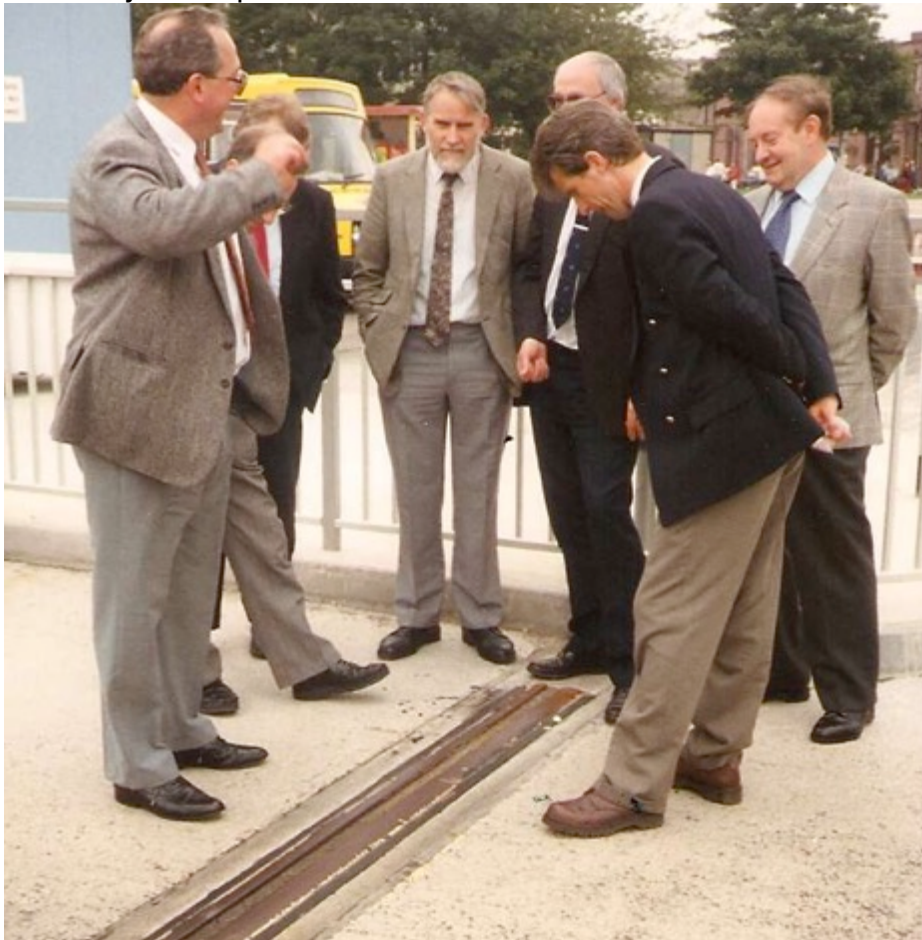
Fig.16 Two year inspection

The condition of the rail at Rotherham Bus Station after two years of field trial experienced no visual deterioration due to road vehicle impacts and weather influences. Similarly there was now physical movement or transposition of the LR55 installation. This indicates that even is a pavement of poor quality, track gauge will be maintained.
